THE EXCAVATION OF A BLOOMERY FURNACE AT HACKENSALL

BY ROBERT F. TAYLOR, B.A., A.M.A.

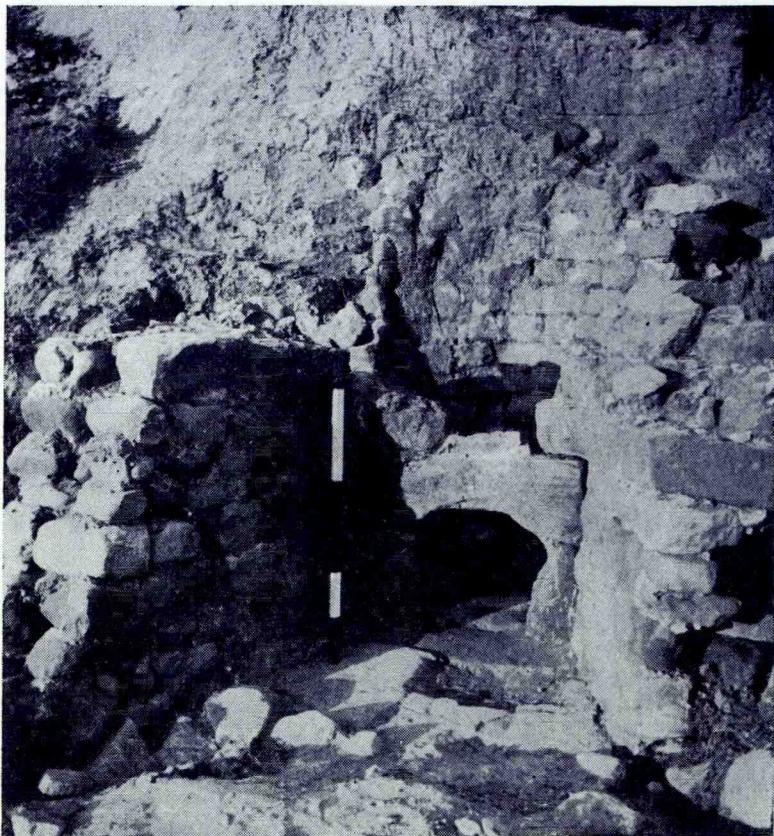
Plate 16.

FORE-HEARTH AND FRONT OPENING OF THE KILN
AT HACKENSALL

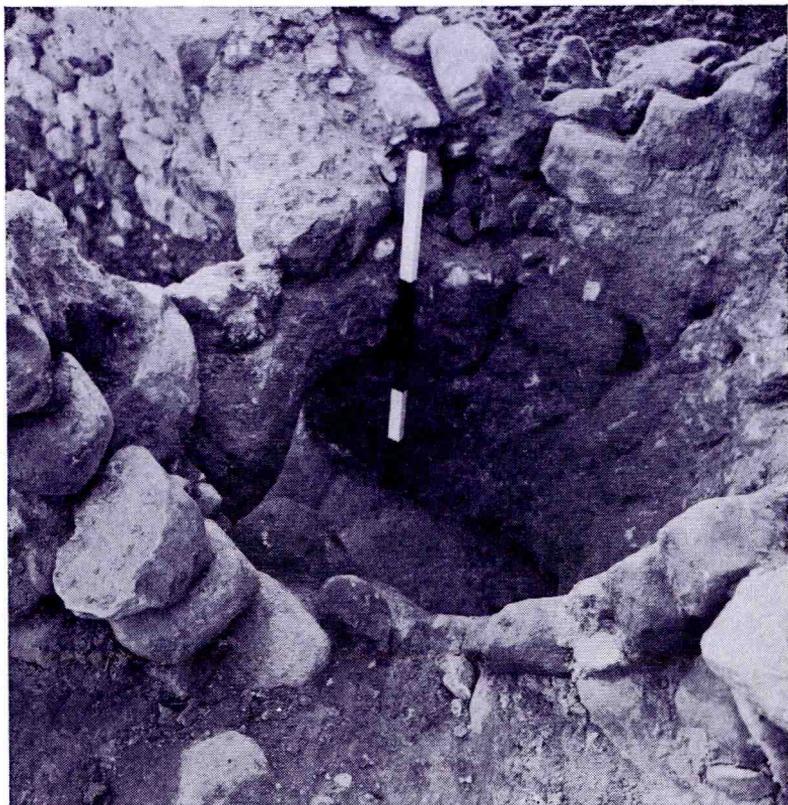
Plate 17.

THE KILN LINING SEEN FROM ABOVE THE REAR OF THE KILN

verted truncated cone, some 1 foot 3 inches by 3 feet at the base, widening out to about 6 feet in diameter, although the original maximum diameter would have been rather greater. At the front of the kiln was an opening 1 foot 3 inches wide and 1 foot 6 inches tall, formed by a slightly cambered lintel of Triassic sandstone resting on two vertical sandstone columns or jambs. Beyond this was a flagged working-area or forehearth, bounded by two sturdy retaining walls of cobbles and Triassic sandstone blocks set in mortar. These had been at least 5 feet long, were up to 18 inches thick, and stood just over 3 feet high. Near the kiln and its arch were signs that these walls had been corbelled inwards, thereby forming a small tunnel, both higher and wider towards its mouth, which would not only have retained the clay cliff on either side, but supported

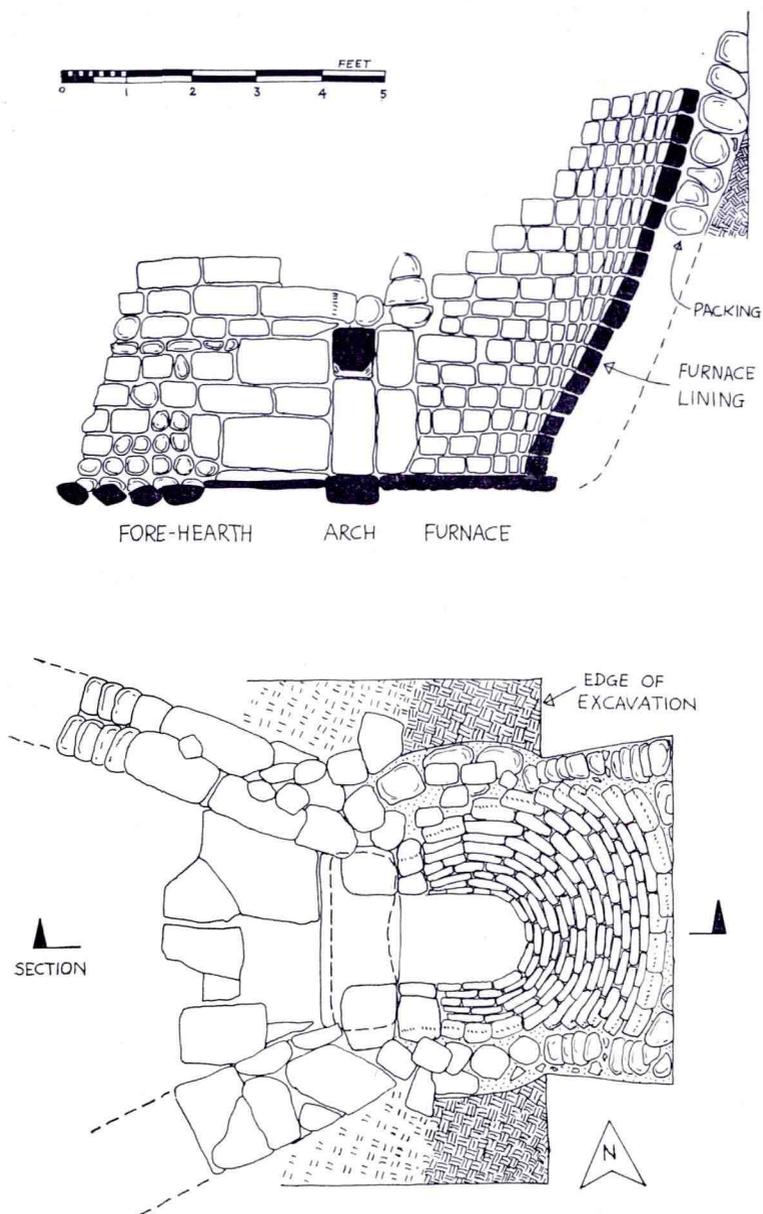
Figure 10.
ELEVATION AND PLAN OF THE BLOOMERY FURNACE
AT HACKENSALL

The bloomery furnace consisted of a kiln and a fore-hearth or working-area in front of the kiln. The first stage in construction had been the excavation of a carefully shaped trench, the eastern or inner end of which matched the profile of the completed kiln. A large stone flag was laid in the bottom of the trench to form the floor of the furnace, and the kiln walls were built up on this. The lining of the kiln consisted of squared blocks of local gritstone, averaging 4 inches high, 6 inches wide and 4 inches thick. They were bonded with puddled clay, which had baked very hard and in some places fused with the iron slag, traces of which remained on the kiln walls. The blocks of the kiln lining were all neatly coursed; the heat of the furnace had caused them to become very friable, which quickened the collapse of the furnace. The 9-inch space between this lining and the back of the trench was filled with boulders from the beach, most of them ultimately derived from the boulder clay of the area, and all laid in such a way as to leave large air-spaces between them. These spaces had become filled with grey rain-washed silt, and there were traces of soot on and between some of the boulders. The function of these packing-stones was probably the double one of insulation and drainage. Heat loss
