THE ROMAN ROAD FROM NEWTON BROOK
TO THE SOUTH OF THE PARISH CHURCH,
WARRINGTON.

An account of the investigation carried through by G. A. Dunlop, F.S.A., and Colonel B. Fairclough, C.M.G., D.S.O.

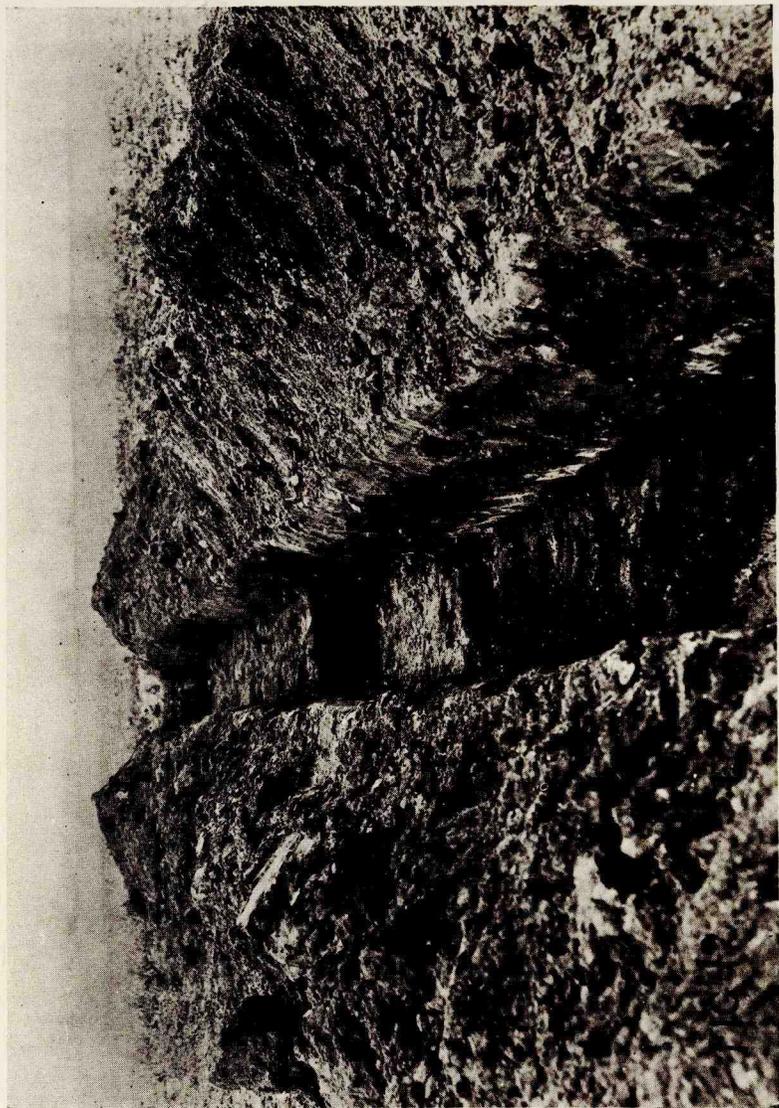
FIG. 12.

ALSO SHOWS TWO SECTIONS OF DEEPER STRATA.

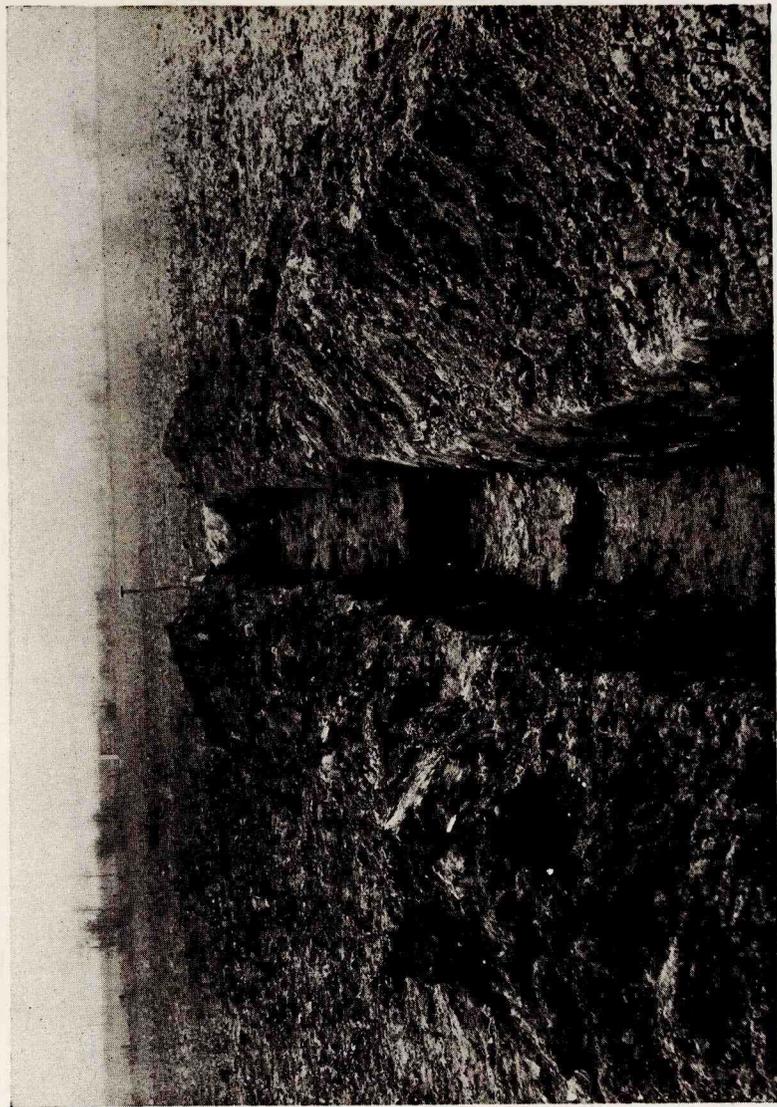
FIG. 14.

ALSO SHOWS TWO SECTIONS OF DEEPER STRATA.

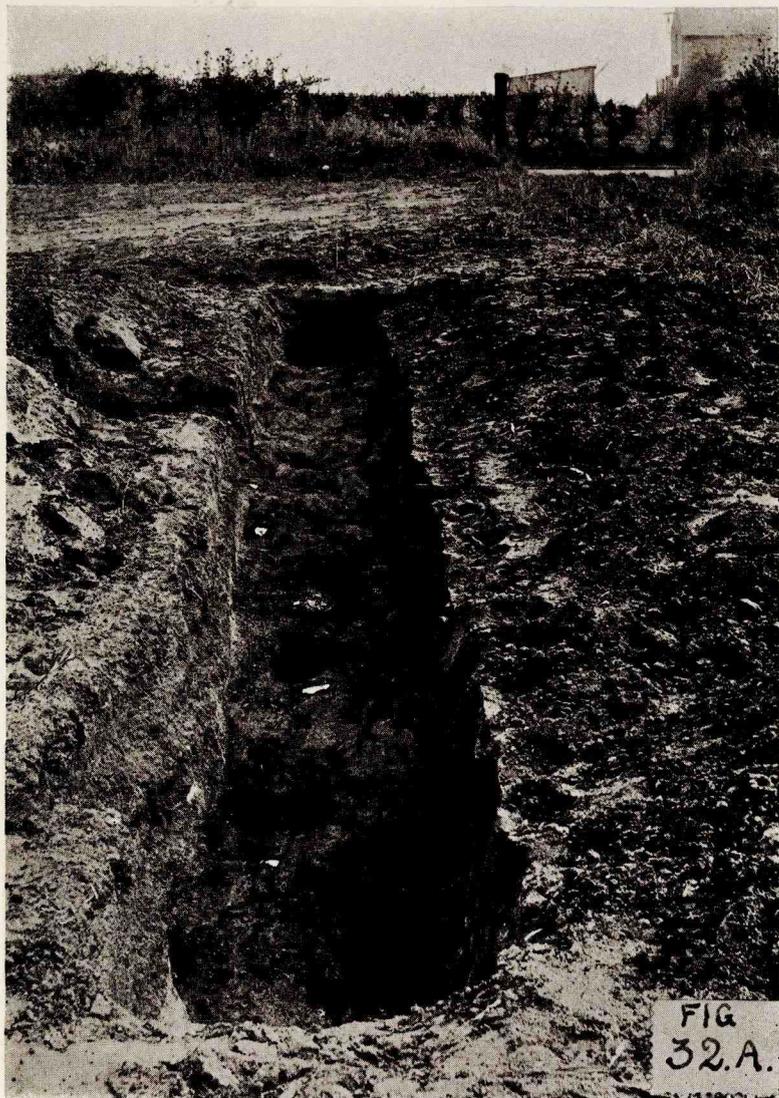
TRENCH WEST OF CLAMBROOK COTTAGES.

In the same field, i.e. west of Clambrook Cottages, we dug a trench 5 yards to the north of the southern hedge and parallel to it—the eastern end being 15 yards west of the field gate on to the main road. Sandstone block paved road surface was found extending 34 feet 9 inches towards the west and farther. For the first 3 yards from the east end the sandstone blocks were much harder than those more to the west. The surface of the Road had well-defined lines of separation between blocks composed of dark grey sand much softer and lighter-coloured than the dark-red sandstone blocks. After the first 3 yards the Road surface had many smallish "puddle holes" 3 inches to 6 inches diameter, and of varying depths, some 6 inches deep, separating the sandstone blocks. These holes were filled with mud or silt. The layer of white sand shown on the sections (*Fig. 32B*) only existed from the west end of the trench to about the middle of the trench length. The parting lines between blocks were very similar to those exposed in the holes (*Figs. 29B and 29C*). A cross-section of the Road is shown in *Fig. 31*, together with four sections of the Road from

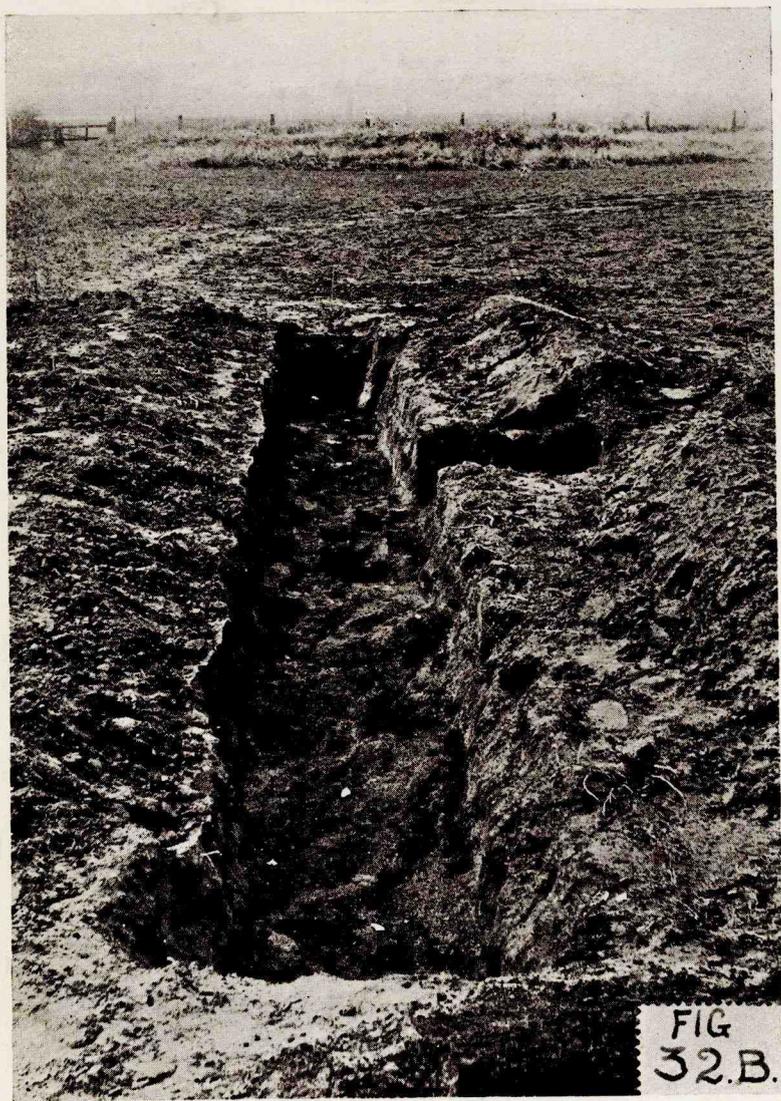
TRENCH WEST OF CLAMBROOK COTTAGES.

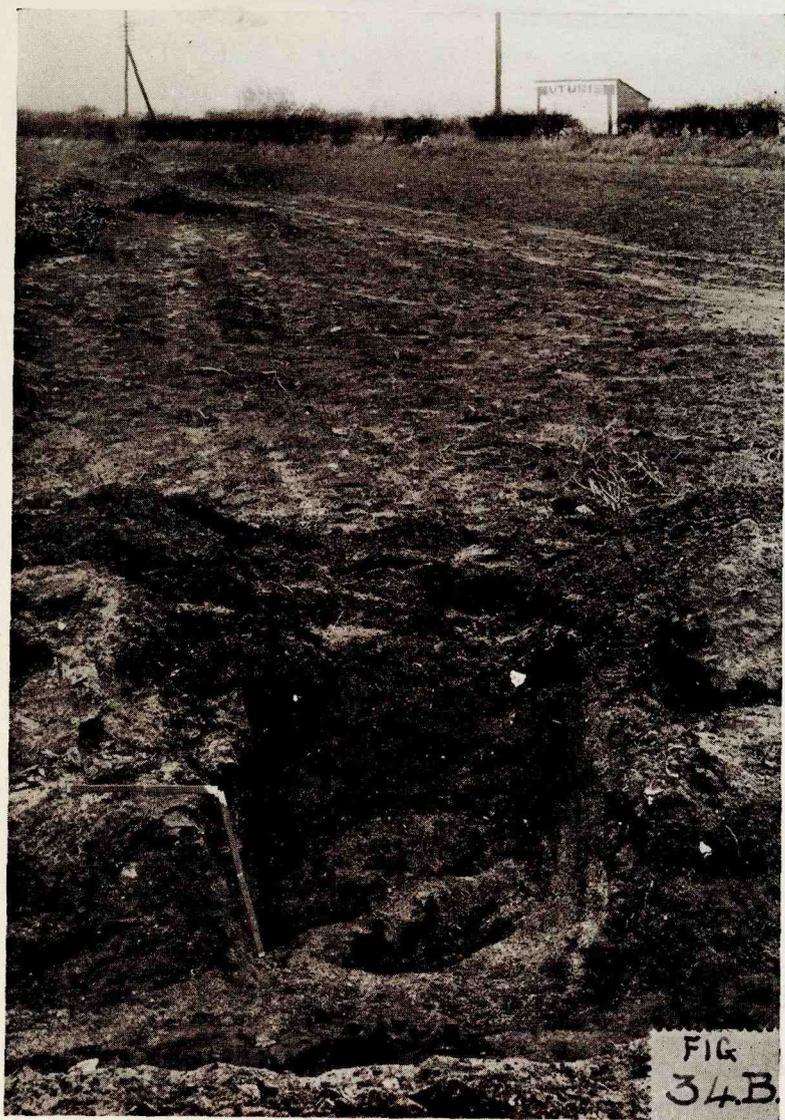
SIDE CUT, CLAMBROOK COTTAGES TRENCH.

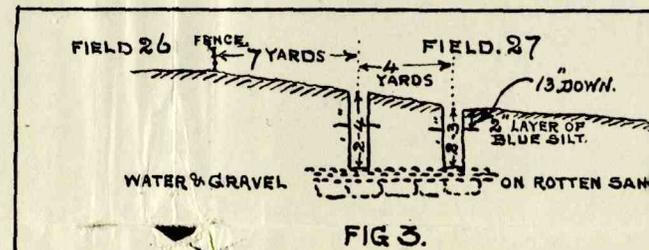
FIG 3.

We went after this to Newton Brook. After locating exactly on the ground the Ordnance "Roman Road" line, we probed and dug two holes, 7 and 11 yards north of the southern fence of field 27, and obtained the sections shown on *Fig. 3*. These holes were dug on a natural-looking slight causeway which slopes down to the north from field 26 towards the bend in the course of Newton Brook, which turns south at this point. The banks of the Brook at this point are very suitable for bridging, but at this date may not be exactly as it was in Roman times. No trace of bridge or ford was to be seen. From the above-mentioned holes, looking south, the ground rises slightly and a gravel band could easily be seen in the corn stubble in the northern half of field 26. The southern half of field 26 having been recently ploughed, the gravel line was very marked. This proved the Ordnance line of the Road to be correct here. A hole dug about 87 yards north of the fence between fields 26 and 36

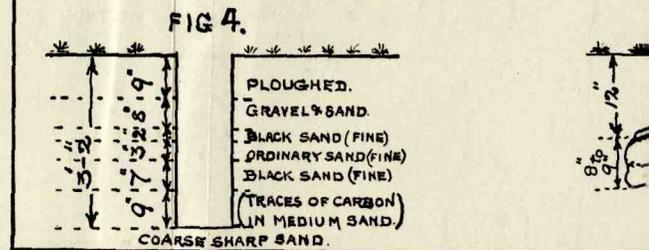
FIG 4.

about the centre of the gravel line gave the following section (*Fig. 4*).

5. The road varies in width, being 14 feet wide in field 36, and 24 feet wide in field 88 (*Fig. 2, Map*). In field 26 the road seems to be made of gravel and sand (see *Fig. 4*).

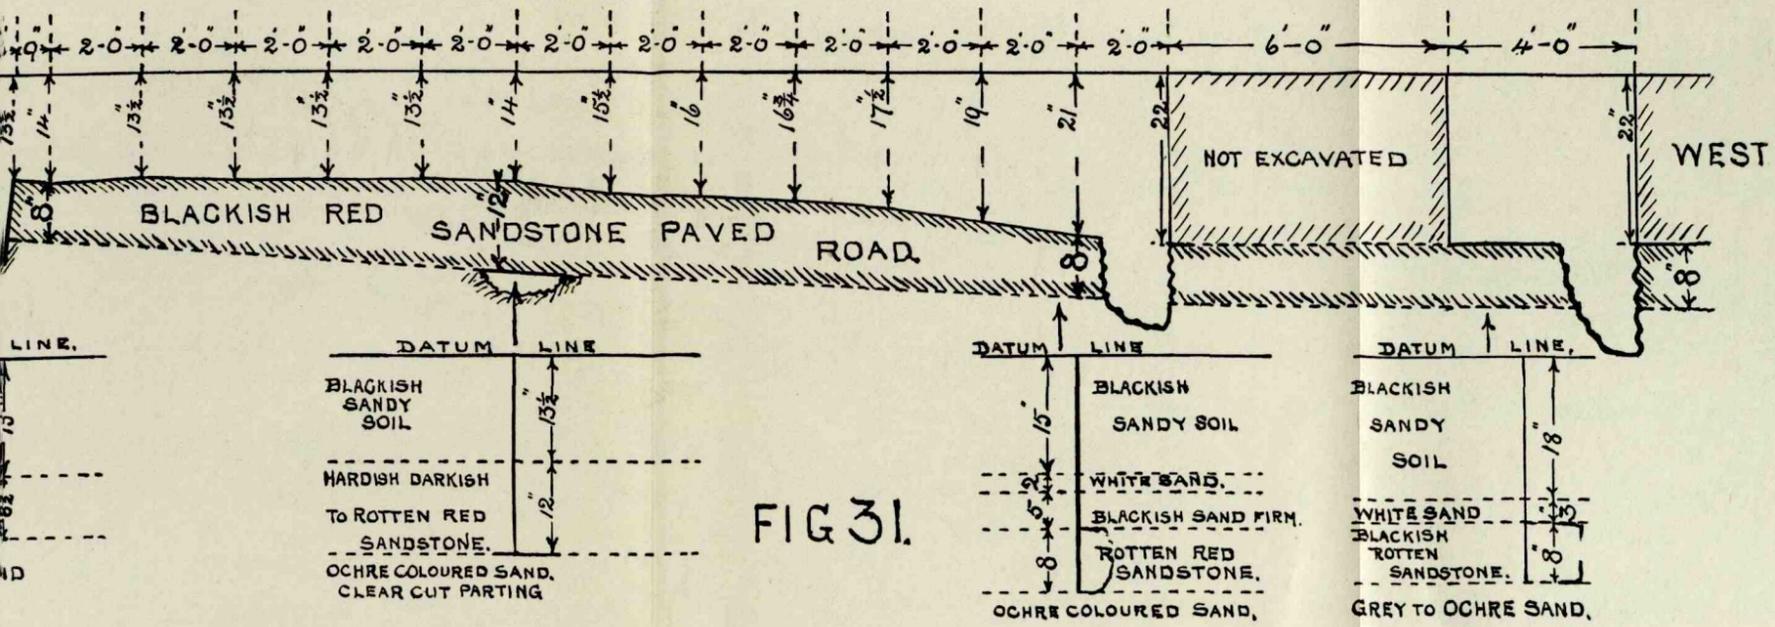
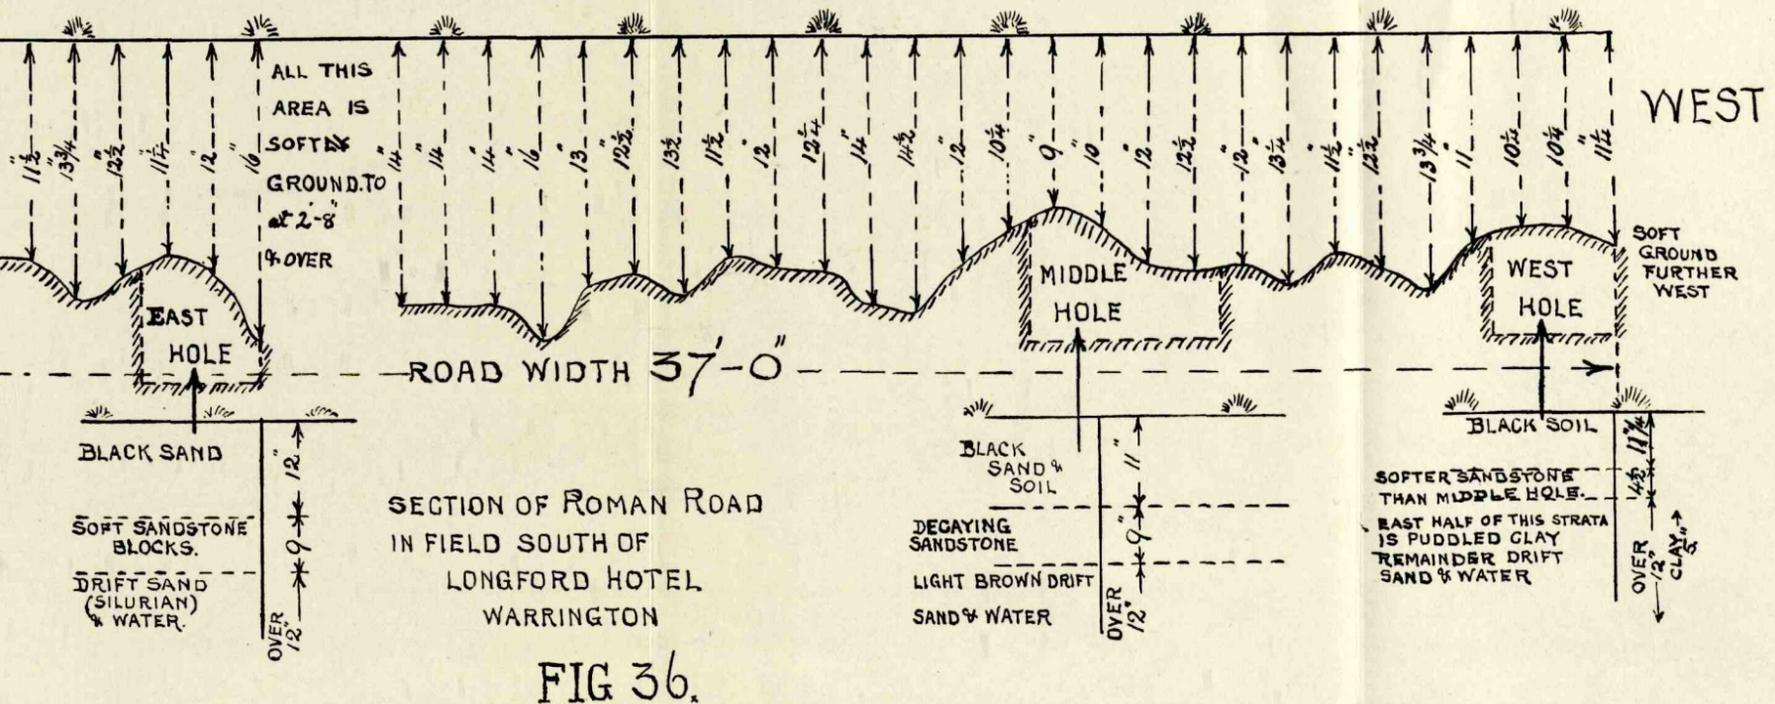
FIG

SECTION OF ROMAN ROAD IN FIELD WEST OF CLAMBROOK COTTAGES.

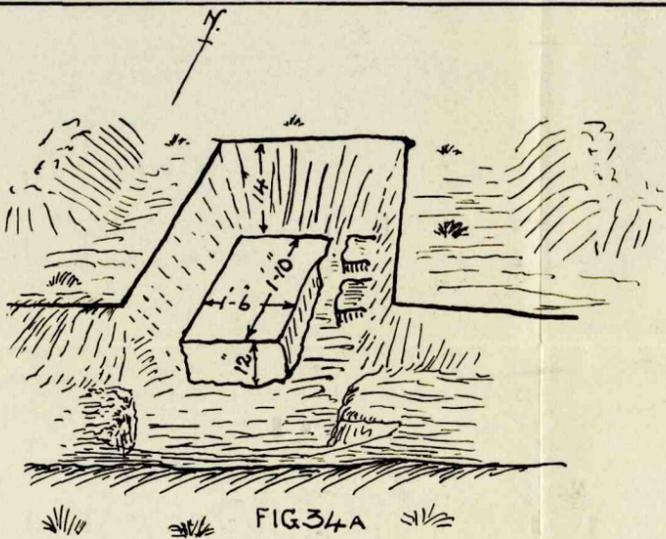
On probing in the opening just west of No. 160 Longford Street, sandstone was again found over a width of 26 feet, roughly 2 feet 8 inches down. A plan of the site and section of a hole dug is given on *Fig. 42*. No signs of gravel were seen. It is evident a change in direction of the Road

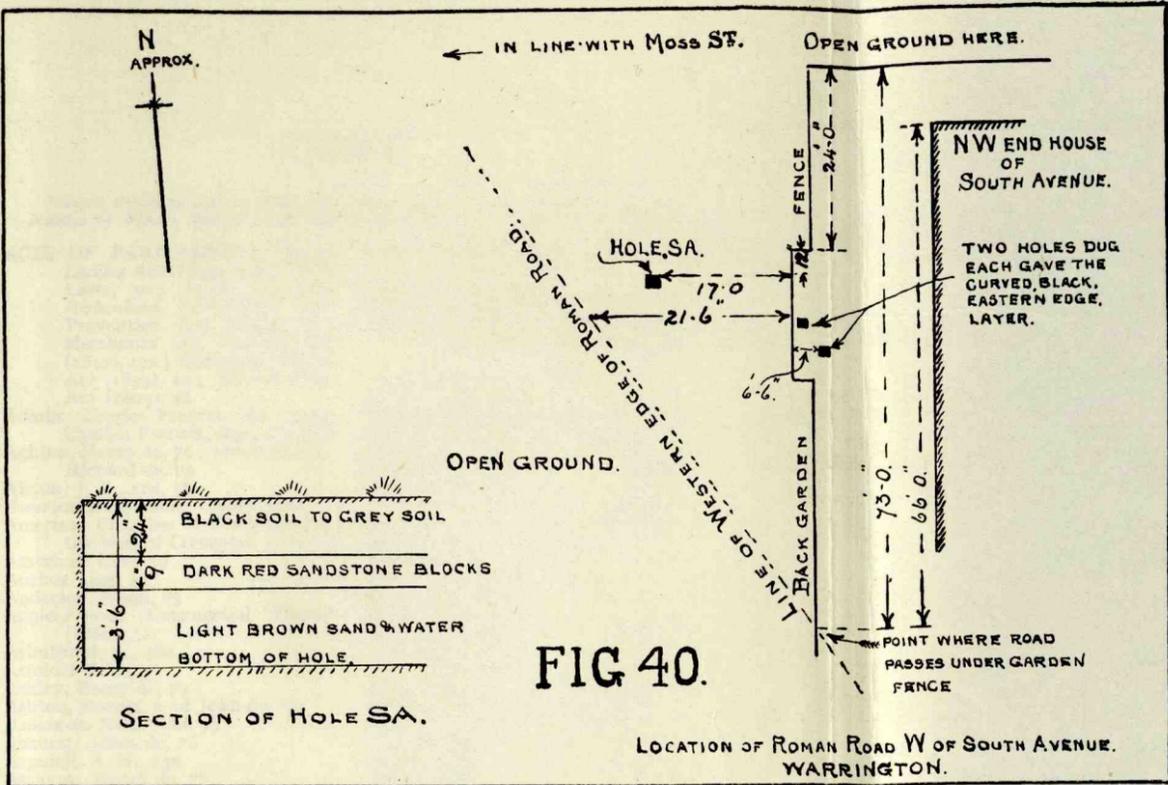
The western edge of the Road was found in the Rectory garden 2 feet 1 inch down and was 7 inches thick, whereas in the eastern hole the sandstone was 18 inches thick. We were unable to distinguish the shape or size of the blocks as they had lost most of their colour and were very soft indeed, but the west edge was definite. Occasional pebbles were found in the 6 inches immediately above the sandstone Road. A plan of the site, together with sections, is given in *Fig. 45*.

with the red sandy soil, a good many gravelly pebbles were found. The dividing-line between the underside of the sandstone road and the underlying grey alluvial sand was very marked. The writer knows very well indeed from personal observation that this area has been flooded several times most winters for over the last fifty years.
